Re: Magna Metals Site - #3-60-003
510-534 Furnace Dock Road
Cortlandt Manor, New York

RE: Sub-Slab Depressurization System (SSDS) – Annual Inspection Report

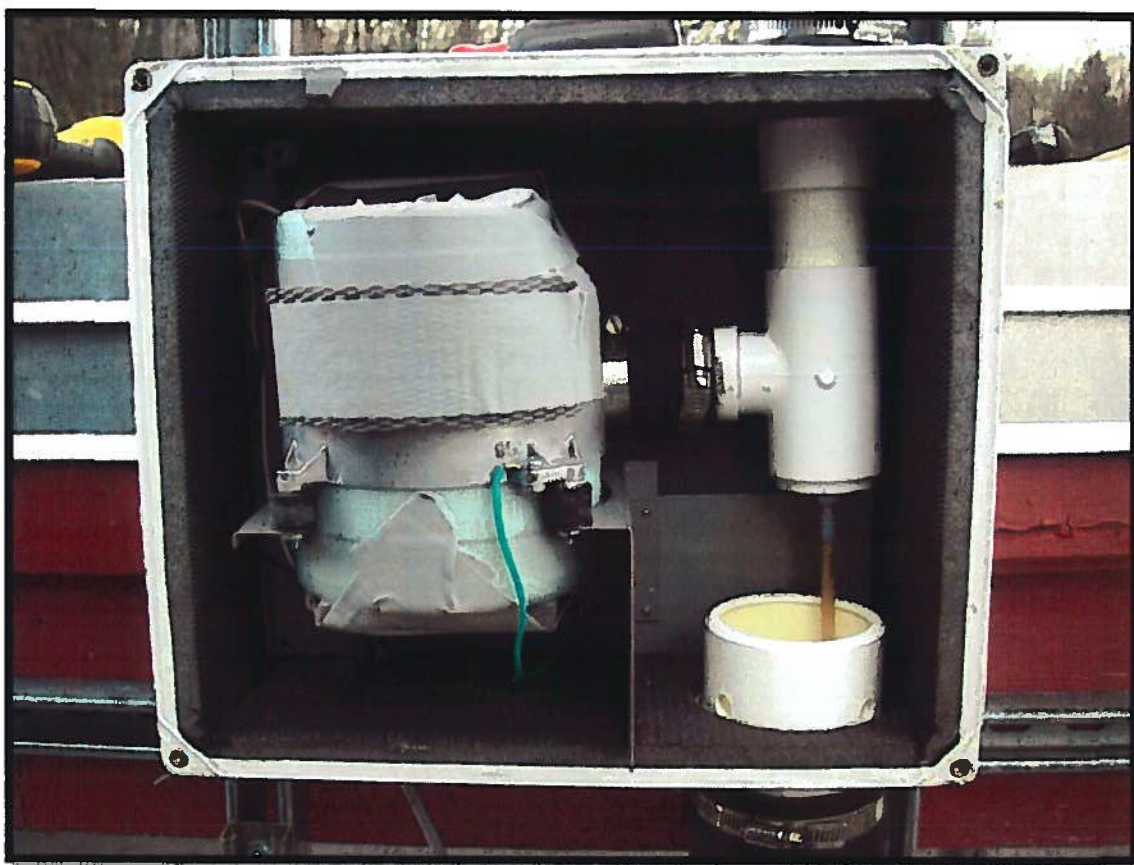
On December 26th, 2013, during a routine inspection of the vacuum indicator lights, the building tenant observed that one of the three lights was illuminated. Aztech was notified the same day by the property manager. On December 30th 2013, Aztech mobilized to the site and confirmed that fan #1 was not running. After multiple attempts troubleshooting and testing it had been determine that the motor had overheated multiple times due to excessive vacuum. After further examination, it had been determined that the motor coils had experienced irreversible damage. While on site fan #2 was tested and displayed amperage above the maximum rated amperage. This fan also showed signs of continuous overheating and potential failure.

Seen here is fan #1 with its protective casing removed. Technicians troubleshooted the fan and motor while on site. The fan was brought back to the shop for additional evaluation.

On March 5th, 2014, fan #1 and fan #2 were replaced with HS-2000 model Radon mitigation fans (previously HS-5000). This model serves the purpose to provide soil vapor mitigation without the excessive vacuum and subsequent overheating which the previous model endured. Air bleed valves were also installed into the existing piping in order to calibrate the level of suction and amperage that the new fans were drawing. This addition will greatly increase the longevity of the system fans. Fan #3 was found to be in good working condition (previously replaced with HS-2000).

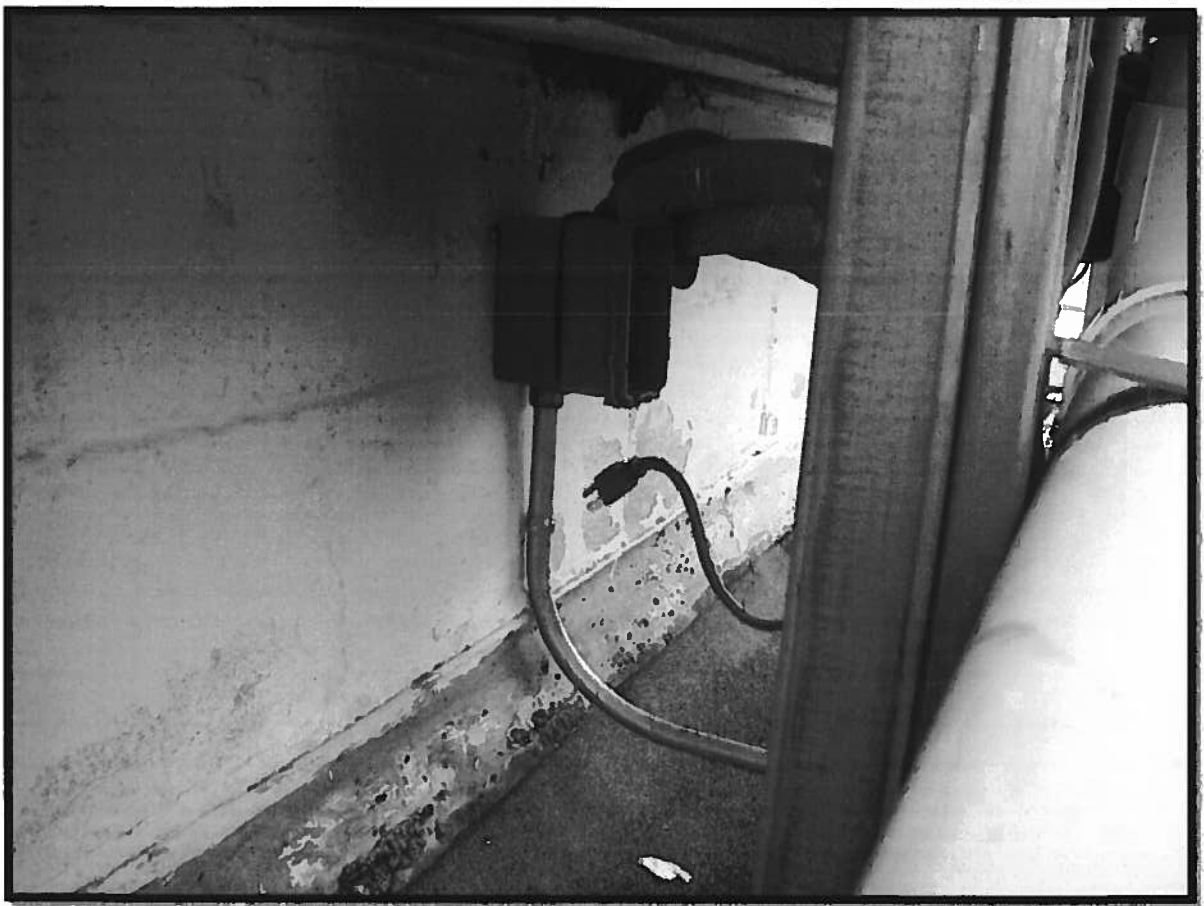
Seen here is fan #2 temporarily unplugged, as it was drawing amperage above its max rating

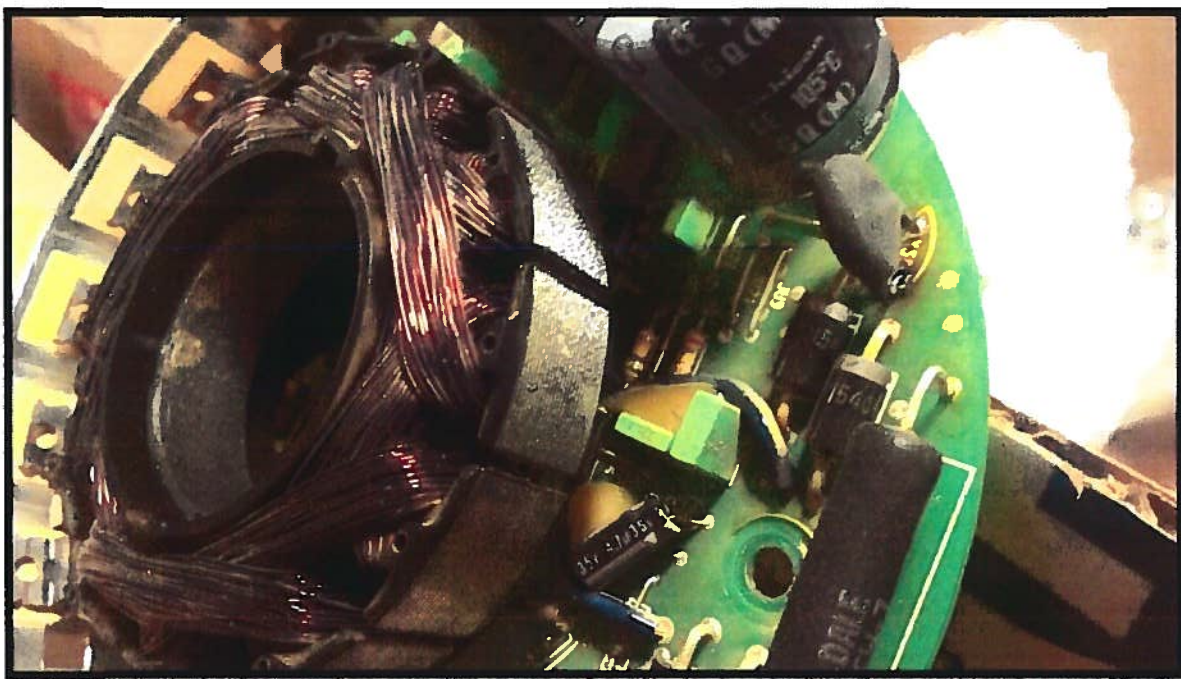
Seen here is the overheated motor coils and burnt out fuses in the upper right hand corner. After replacing the fuse, the motor continued to draw amperage above acceptable limits.
